FULKING CONSERVATION AREA

Mid Sussex District Council

May 2008

FULKING CONSERVATION AREA APPRAISAL MAY 2008

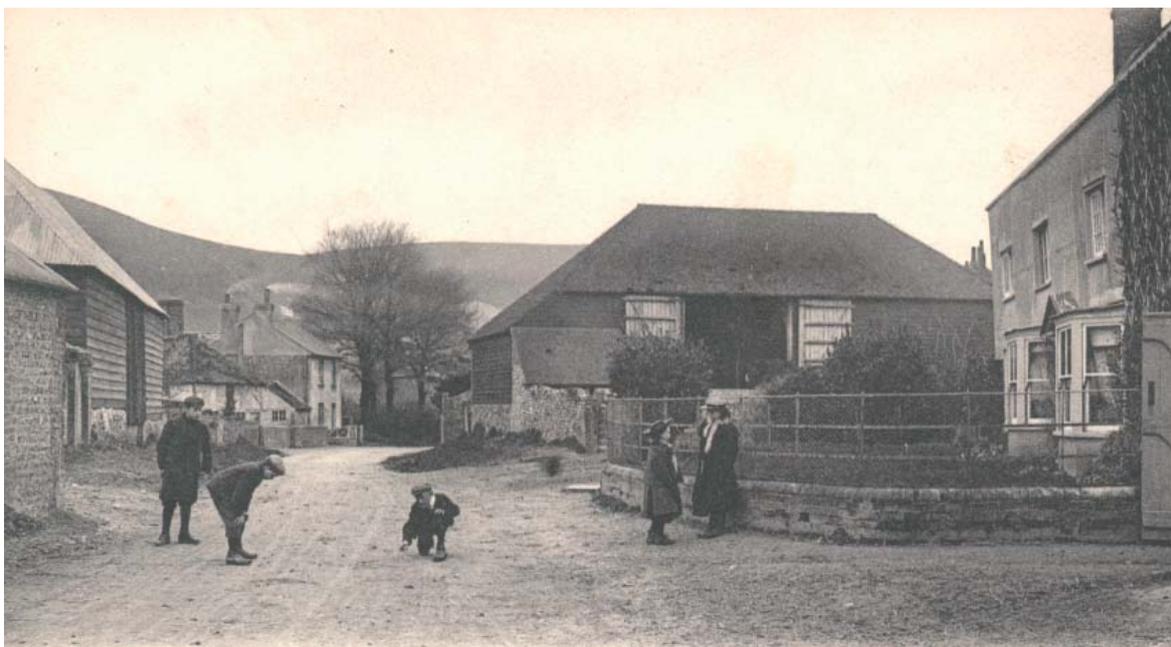
c1906

4.3 One of the key characteristics of the conservation area is the narrowness of the Street – in certain sections it is less than five metres across – which helps to create an intimate atmosphere. Amazingly, the Street was once even narrower than it is today, being punctuated by various farm buildings that stuck out into the road, as shown in the photograph overleaf. It was eventually widened during the 1950s, as motor vehicles started to become more commonplace.

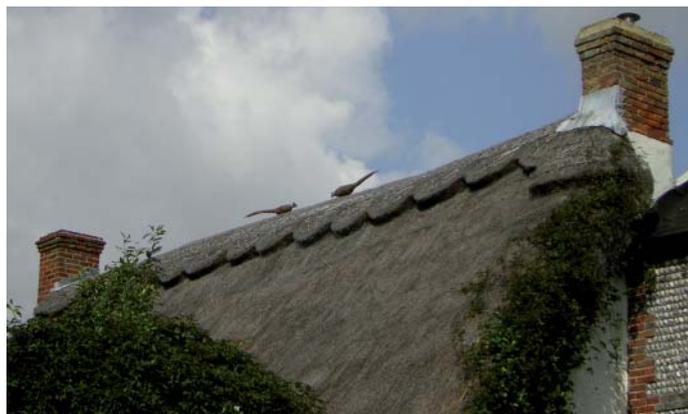
- Coursed flint;
- Coursed cobble;
- 'Bungeroosh' (an irregular mix of brick, chalk and flint);
- Local orange/red bricks – originally mainly for quoins and detailing;
- Lime render (limewash);
- Handmade plain clay tiles for roofs and vertical hanging.

Stone usage was limited and usually confined to quoins and detailing. It is extremely difficult to form sharp angles using flints or cobbles on their own so elements requiring defined edged were normally constructed in brick or, in some cases stone.

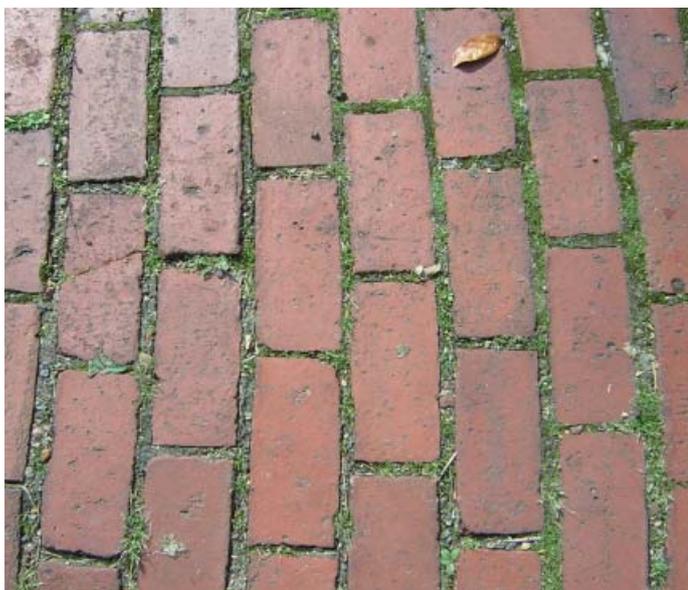
8.3 Residents have utilised a variety of materials for private driveways. The most popular material appears to be gravel, however, others have used paving slabs, bricks (laid out in a stretcher pattern) and tarmac. Again, locally sourced building materials are encouraged wherever possible.

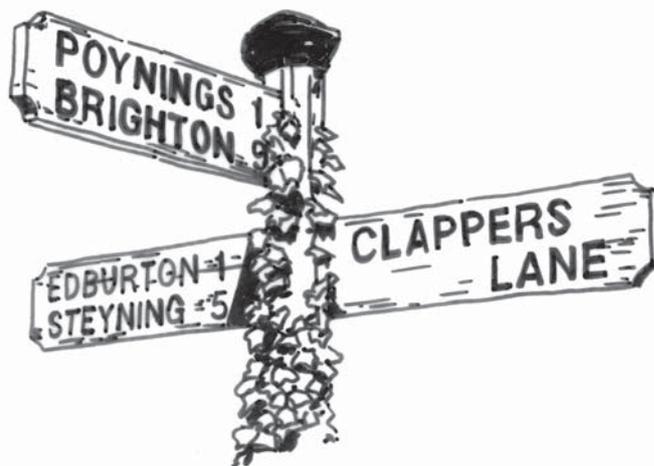
9.3 Other significant pieces of street furniture

within the conservation area include railings, a wooden 'fingerpost', a wooden bus shelter and a listed red telephone box.

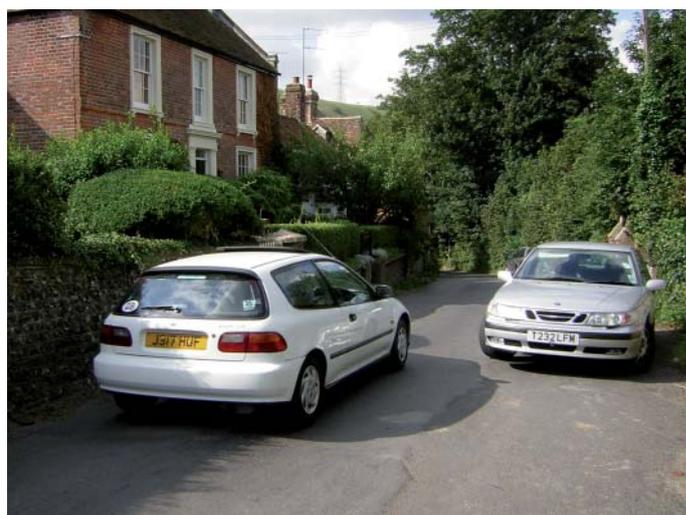
12.1 Visitors and those residents, who do not have a private garage or driveway, compete for the limited on-street parking spaces in the village. At times the available parking is insufficient. The combination of the narrowness of the road and cars being parked on tight bends can make the Street dangerous for pedestrians and motorists alike. This is particularly a problem at weekends when the Shepherd and Dog is an extremely popular destination for day trippers.

- Carry out a street audit and identify whether a scheme to manage and calm traffic, whilst improving the appearance of the street scene is required.
 - Discourage the replacement of timber windows with UPVC windows and the construction of UPVC conservatories in the Conservation Area.

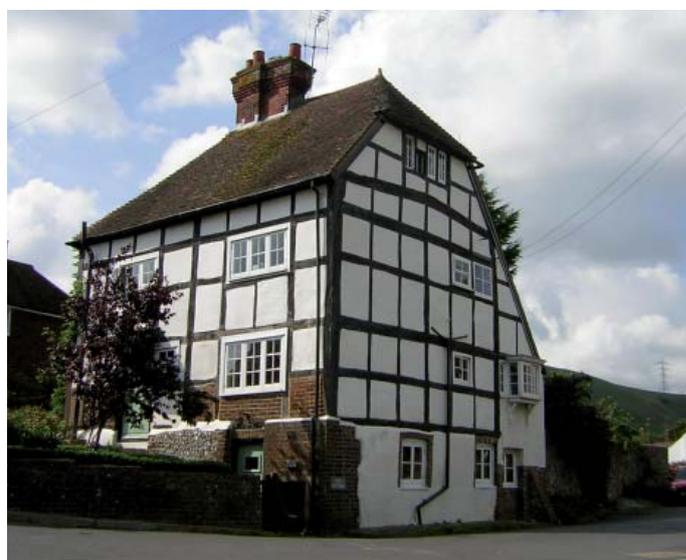
15.1 The first buildings to greet the visitor upon entering the conservation area from the east are three relatively modern residential properties: Woodlands, Conifer House and Spring Valley. Sheltered behind a substantial flint wall. The land on which all three dwellings now stand had, at one time, been a pig farm. Whilst parts of Woodlands and Spring Valley date back over a hundred years, both have been extensively renovated. Conifer House is more recent, having been built in the early 1960s. Spring Valley is quite a charming house with a tile-hung second storey and two wooden balconies. The eastern side of the house comes right up to the road, which helps create the intimate nature that exists in the village.

15.2 Whilst these three dwellings are not architecturally significant, they mark the start of the 'built-up', centre of the village. Furthermore, the flint walls that run along the road in front of each property, signpost the centre of the village and act as a precursor to the walls that are such a distinctive feature of the central section of the conservation area.

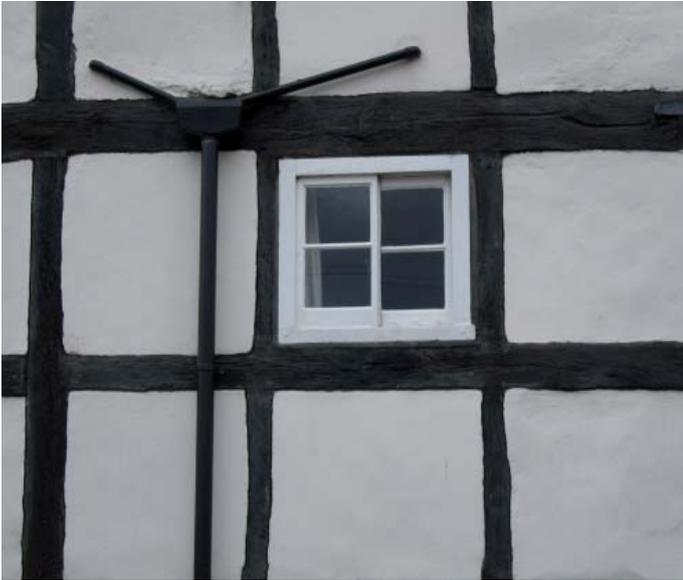
15.3 From here, the eye is drawn to the imposing presence of Kent Cottage, situated on the inside corner of a sharp bend in the road. This unusual Grade II Listed building was once much larger and was used for a time as an infirmary and workhouse. It is still three storeys in height with a large attic in the gable end. Thought to date back to the seventeenth

century, it owes its striking appearance to its half-timbered construction with plaster and brick infilling, on a base of flints. The timber framing in large braced panels, so noticeable on the outside, holds the building together. The beams of the first floor are all stop-chamfered.

15.4 Kent Cottage sits on top of a ninety-degree bend on the Street, which can be quite hazardous when cars approach too fast, as the building significantly reduces visibility. It marks the start of a relatively straight east west stretch of the Street, which forms the backbone of the central section of the conservation area.

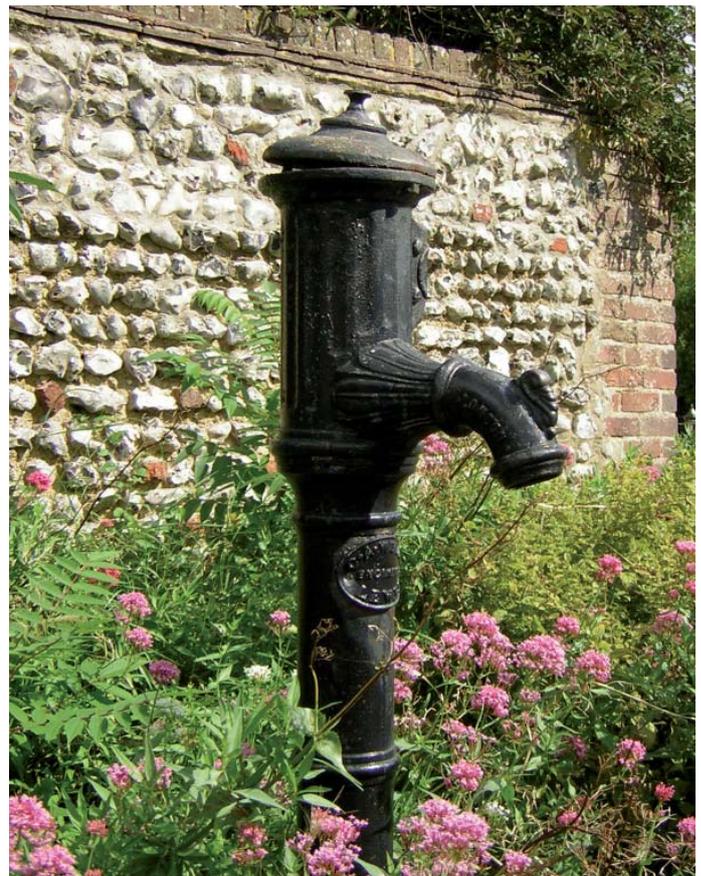
15.8 In the front garden of Fulking Farmhouse is the first of two listed hand pumps situated along the Street. They form part of the unique water supply system that was installed in the nineteenth century. Whilst it no longer serves its original purpose, it provides a reminder of a world that has now long gone.

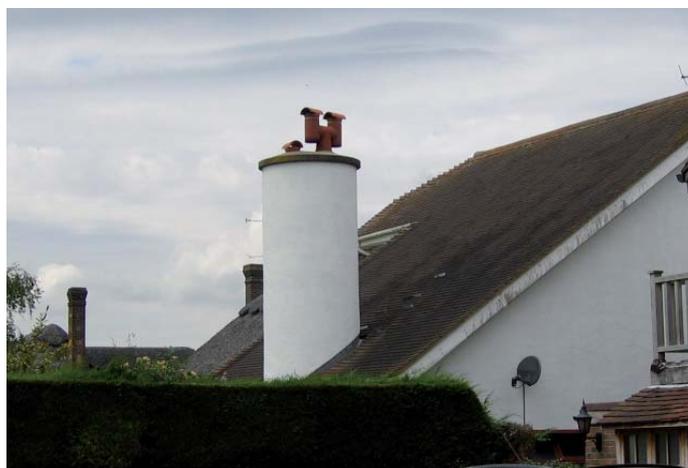
15.11 Chimney House is located to the west of Kent Cottage but the only feature it shares with its neighbour is a sense of bulk. Dating from 1976, it is of a fairly bland, modernist design, although it does feature an unusual 'ship funnel' style chimney to the rear, which gives it its name. Whilst it does retain an original flint wall along the northern boundary, facing onto the Street, the recent addition of substantial wooden security gates have obstructed views of the Downs from the road.

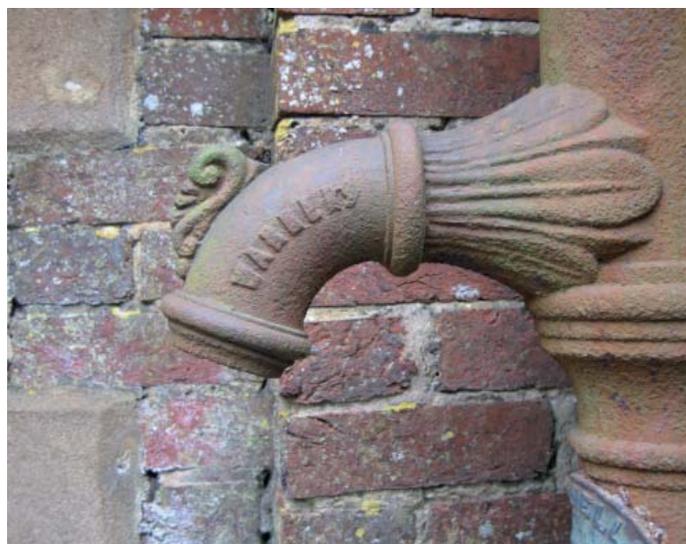
15.13 On the pavement in front of Broadreeds are two pieces of listed street furniture. The first is a Grade II listed, red telephone box (Type K6). The K6 was originally designed by Sir Giles Gilbert Scott in 1935 to coincide with the Jubilee of King George V, although it is thought that the example in Fulking is more recent. Approximately 14,000 examples of the K6 have

survived around the country, of which around 2,500 have been given Grade II listing.

15.14 The other listed item is the village's second hand pump. This Grade II listed pump is yet another component of the water supply system installed in 1886. Made out of cast iron, the pump has a fluted and domed top with a finial and decorated spout, engraved with: 'Warners, London'. The cylindrical shaft has a plaque, labelled 'C. A. Wells Engineers, Lewes'. On the opposite side of the Street from the pump and telephone box is a bus shelter constructed out of wood and brick (located in front of Coombes), which has recently been renovated.

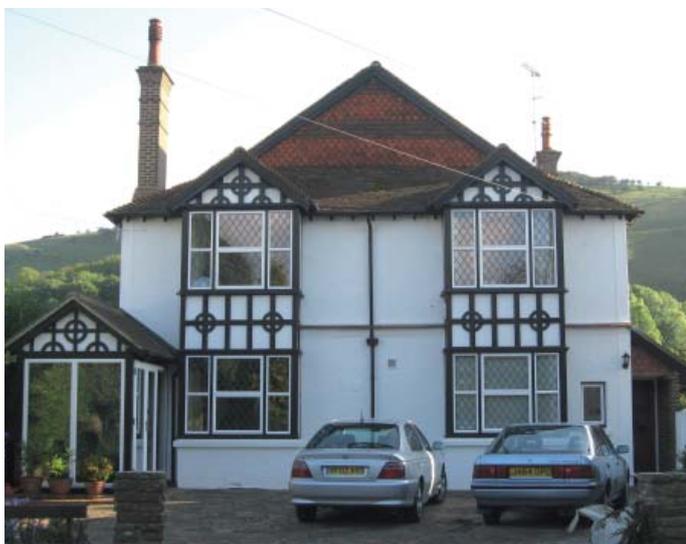
15.17 Next door to Customary Cottage is the imposing Fulking House. Located on the site of three old cottages, Fulking House is actually a lot older than its external appearance suggests, dating back to 1910. It is an unusual, slightly unsymmetrical design with tall, slender chimneys and it's Edwardian architect has tried to incorporate the pattern of its neighbour's half-timbered gable end.

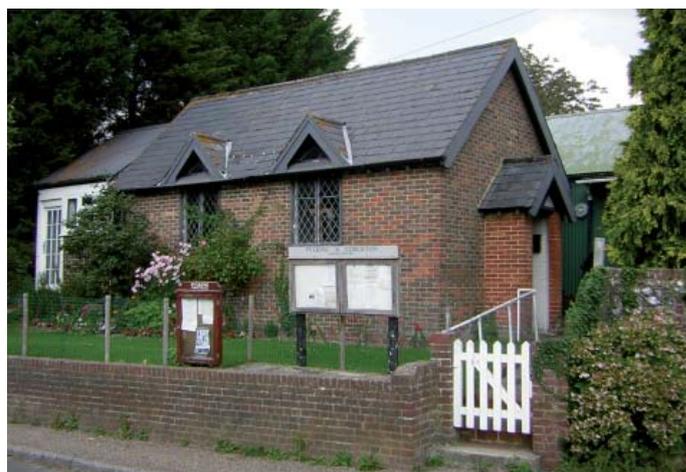
15.19 Opposite to Fulking House are two single storey buildings, which are built almost on top each other. The first is a small brick chapel, built as a Chapel of Ease in 1925. Wrapped behind it is a corrugated iron building built on a brick base, which serves as the Village Hall, although officially it is the Church Hall. Inside it there is a small stage and it is used as a venue for various functions, including a pre-school group. As Fulking no longer has a shop, the hall is one of the few places in the village that local residents congregate on a regular basis, besides the Shepherd and Dog public house. Whilst it serves an important function it is now in a fairly dilapidated state and the kitchen facilities in particular are in need of updating. One of the proposals for enhancement suggested in the second part of this Appraisal, is that the hall be redeveloped.

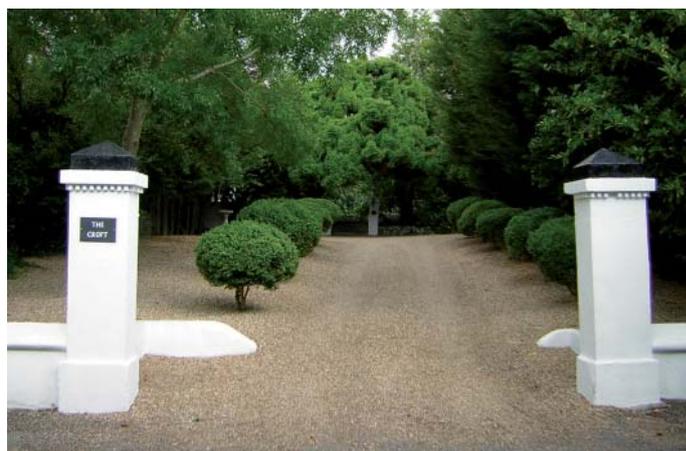
15.20 Next door to the chapel and hall, is a grand gravel entranceway, which leads up to the Croft, a large Victorian house built in 1890. Facing on to the Street are low walls and gateposts rendered white, which until relatively recently had iron railings on top.

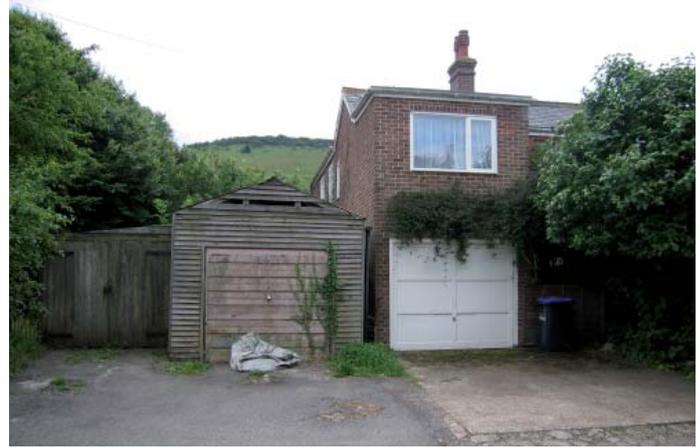
15.29 Adjacent to Jasmin Cottage are two dilapidated wooden garages that, coupled with a bland extension to the house itself, form one of the least attractive parts of the Conservation Area. The Cottage originally dates back to the nineteenth century, however the northern façade is almost entirely hidden from view by overhanging foliage. Unfortunately, the only section of the building that is clearly visible from the road is the extension to the eastern side, which comprises of a garage with rooms above.

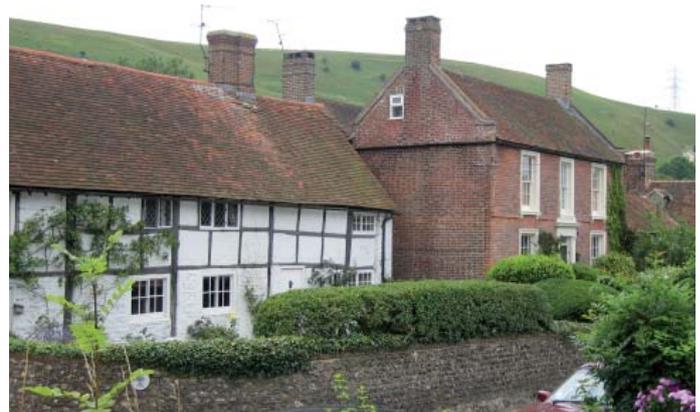
15.30 To the west of Jasmin Cottage is the first of four Grade II listed buildings in a row – Arbor Vitae. This seventeenth century timber-framed building has brick and flint infilling and a tiled roof. The casement windows on the first floor have diamond-shaped panes. The house has been altered and extended on numerous occasions over the years. Most recently an extension was added to the south side in 2004/05. There is a well in the front garden. Some large wooden security gates have been added, which are far too prominent and out of keeping with the rural nature of the village.

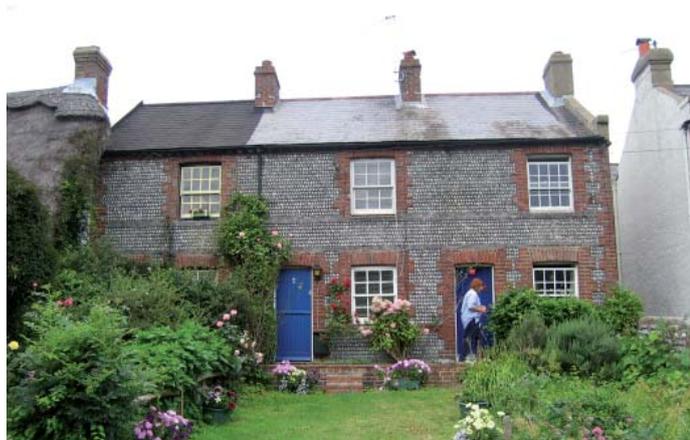
15.33 On the northern side of the Street from Arbor Vitae is Teapot Row, a Grade II listed terrace of three workers cottages. Although built at a later date (thought to be around 1830), this terrace mirrors the façade of the Old Post

Office with cobble-facing, red brick dressings, quoins and an eaves cornice. They also have a string course of grey headers.

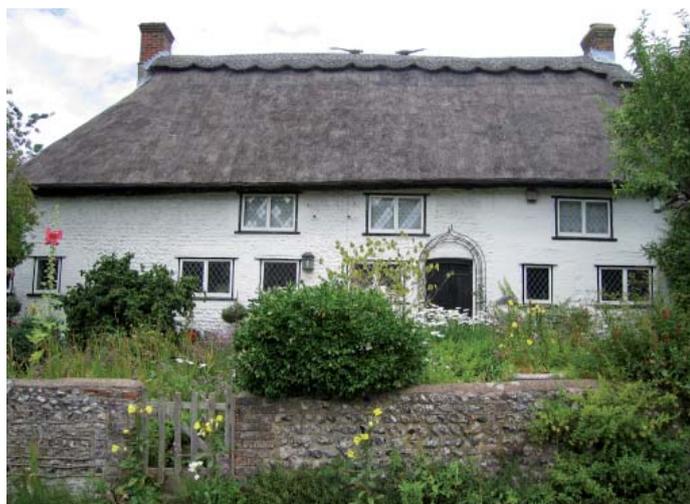
15.34 The large thatched building attached to Teapot Row is the appropriately named Old Thatch. This barn-like structure originally would have had a timber-framed façade similar to Kent Cottage, however it is now faced with flints and brick, painted white. It retains its casement windows, some of which have diamond panes.

15.35 Old Thatch was probably originally built in the seventeenth century and was once four separate cottages. It now has a delightful south-facing English country cottage garden, including an apple tree in the eastern corner. It also has a fine flint wall fronting on to the Street with a quaint little wooden gate.

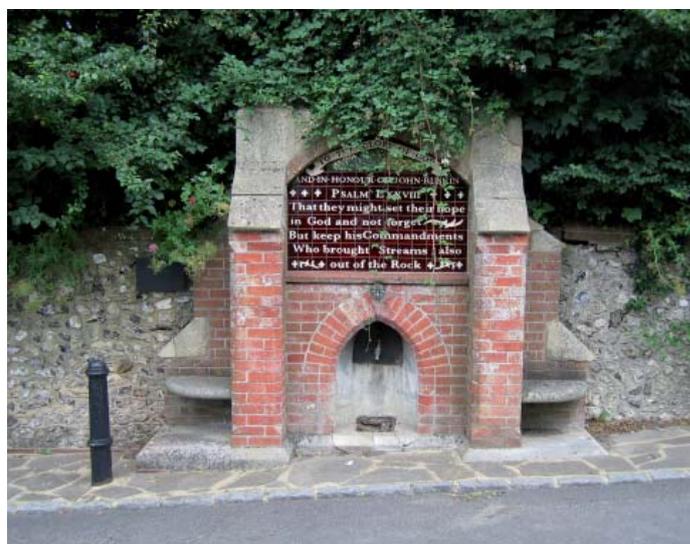
15.36 Just as the Street starts to run downhill to the southwest there is a wonderful Grade II listed piece of street furniture that combines an underground reservoir, a drinking fountain and a water trough. This is an intrinsic feature of

15.38 The surround is flanked by chamfered brick piers with stone heads and carved stone spandrels and further piers at side that enclose stone seats. On either side are stone retaining walls, ramped up in the centre with brick dressings. On the left there is an integral stone animal trough and any surplus water was returned to the spring stream along a drain. Although the Parish Council restored the structure in 1995 (with grant aid from West Sussex County Council, Mid Sussex District Council and Sussex Rural Community Council), it is already showing signs of wear and tear.

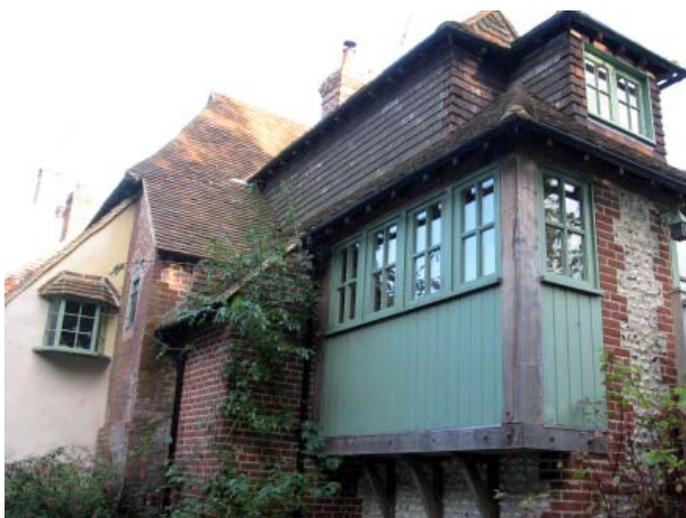
15.40 Despite its nineteenth century name, Primrose Cottage actually dates back to the seventeenth century. It is faced with painted flints and has horizontally-sliding sash windows and a small bay window on the ground floor. The listing description notes that, like Laurel House, it was awarded a Grade II listing for its group value.

15.41 Located next door to Primrose Cottage on a rocky outcrop, the two Septima Cottages are some of the oldest buildings in the village. It is thought that they date back to the seventeenth century or possibly even earlier. Essentially they are one building and it is difficult to make out 1 Septima Cottage from the road, as it is tucked behind its adjoining neighbour (2 Septima Cottages). Both cottages are timber-framed, refaced with red brick on the ground floor and tile-hung above. They have been carefully restored over the past twenty years and a fine extension was added to 2 Septima Cottages in 2006.

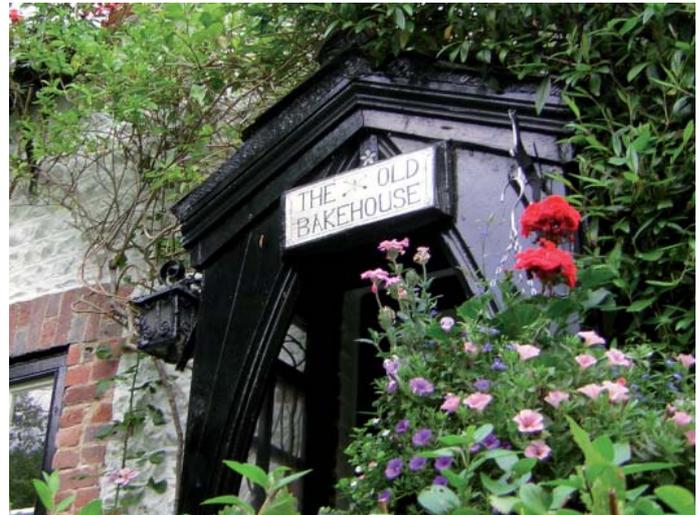
15.43 Before the pub, on the left hand side of the Street, is the Old Bakehouse. The present building dates back to the mid-eighteenth century although it is thought that there had been a house on this site for at least a century beforehand. The bakery was established during the nineteenth century and proved to be so popular that the rock face to the west of the house was excavated to allow a wood-fire oven to be constructed.

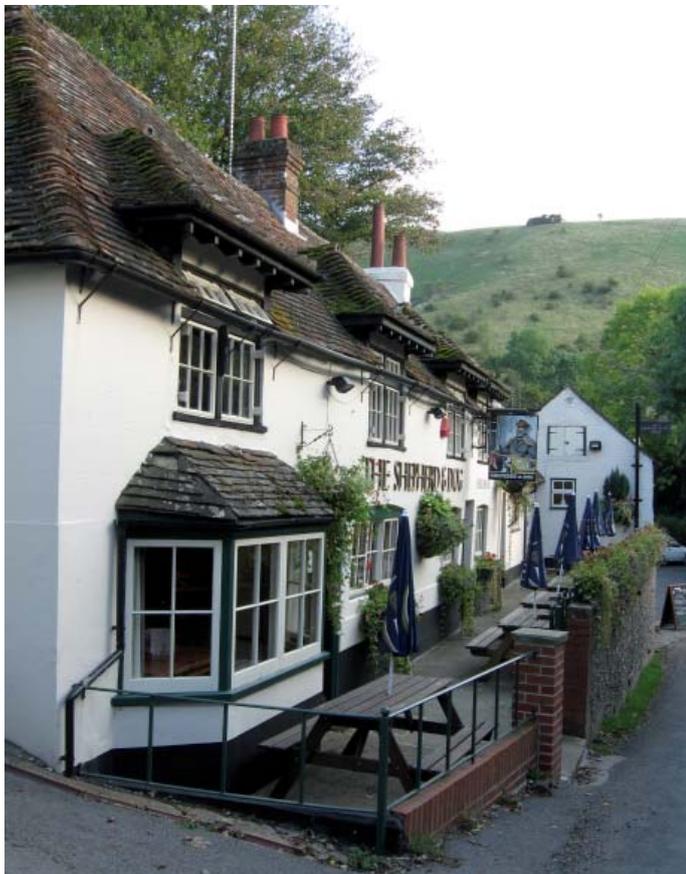
15.46 Although the Inn has a timber-framed construction it is now wholly faced with stucco. Indeed, it has been altered on several occasions down the years. It has a hipped tiled roof and casement windows, with those on the first floor enlarged to form hipped dormers. There is also one bay window on the ground floor.

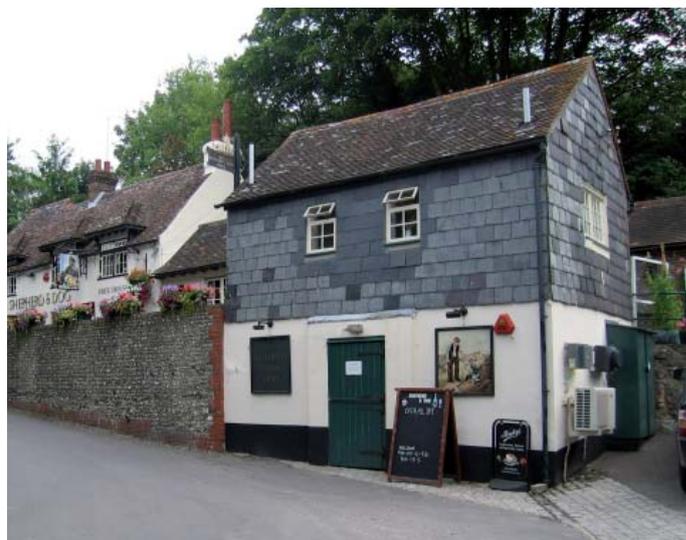
15.48 Like the Shepherd and Dog Public House itself, the pub's old stables have been given a Grade II listing. Now used as a storeroom and lavatories, the old stable building dates back to the eighteenth century and has a stuccoed ground floor with a slate-hung second storey above.

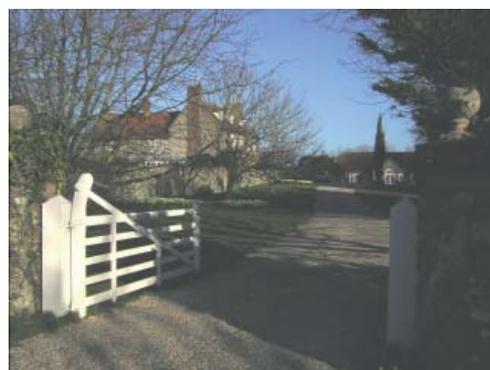
17.3 Perching Manor Farmhouse is the only Grade II* Listed building in Fulking. This fine L-shaped, eighteenth century house is faced with squared knapped flints and features red brick dressings quoins, stringcourse, modillion eaves cornice and panels between ground and first floor windows. The ground and first floor windows have segmental heads and pointed Gothic glazing. In addition, there are three gabled dormers protruding from the tiled roof. The doorway features pilasters and a projecting cornice, a fanlight with gothic glazing and a door of 6 fielded panels.

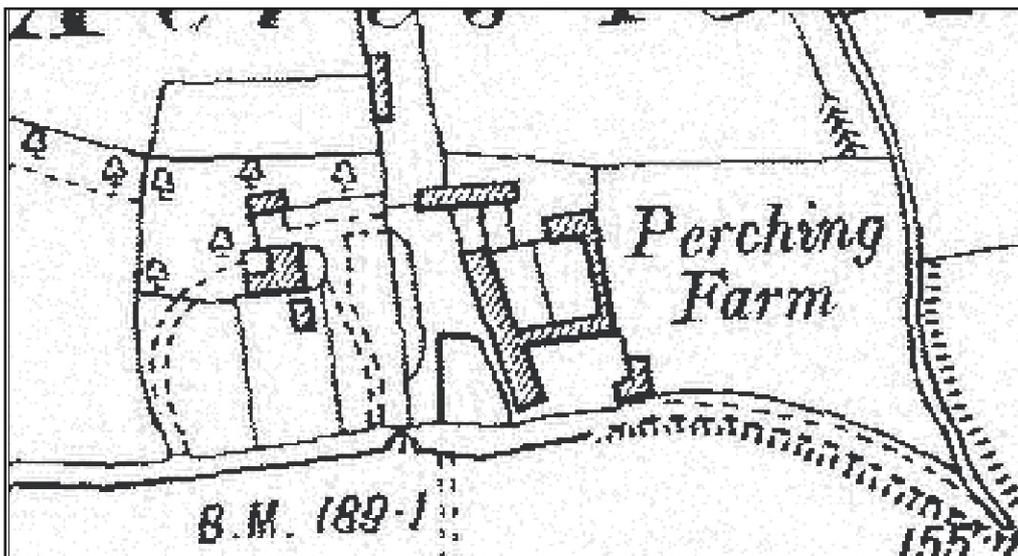
Although now converted into modern residences, Perching Barn, The Granary and Stable Cottage can quite clearly be recognised as the farm buildings shown on this map from 1910.
